**Re: OIA request – Mental Health unit data**

Thank you for your Official Information Act request received 10 December 2020 seeking information from Waitematā District Health Board (DHB) about our mental health facilities.

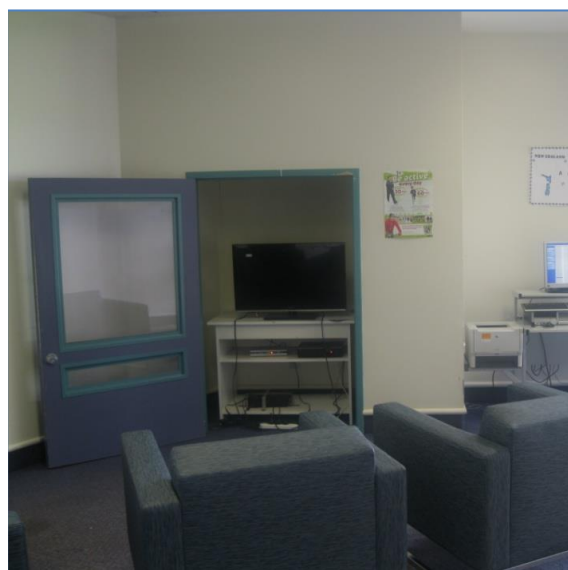
Figure 5: Rata Unit

45. The Mason Clinic has a number of buildings that have deteriorated significantly over several years as a result of water damage. Rata Unit is one of those buildings. A works programme has been established to progressively address repairs to the affected buildings<sup>4</sup>.

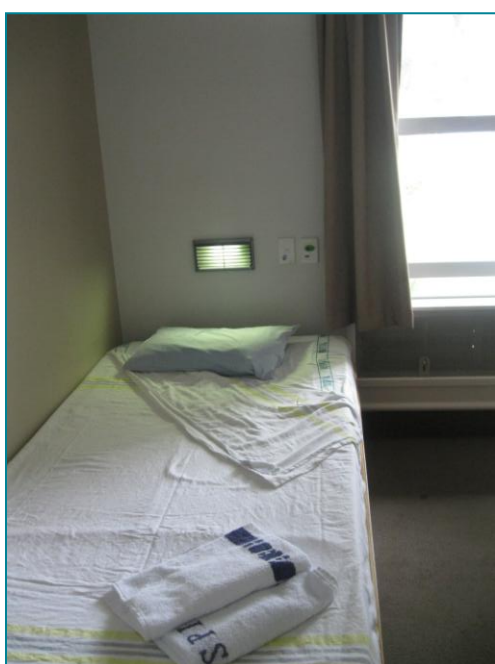
41. Set in the grounds of Waitakere Hospital, the Unit, both inside and out, was clean and tidy and had a spacious feel about it.
42. Client bedrooms in Pukeho and Takahe (two with en-suite facilities) are reasonably spacious, with adequate storage and natural light. Bedroom doors can be locked from the inside and windows have curtains for privacy. Bedrooms in the ICU were a little more austere than those in the main unit but were clean and tidy and offered adequate privacy. Some graffiti was noted in bedrooms.

Figure 5: Typical bedroom in main ward

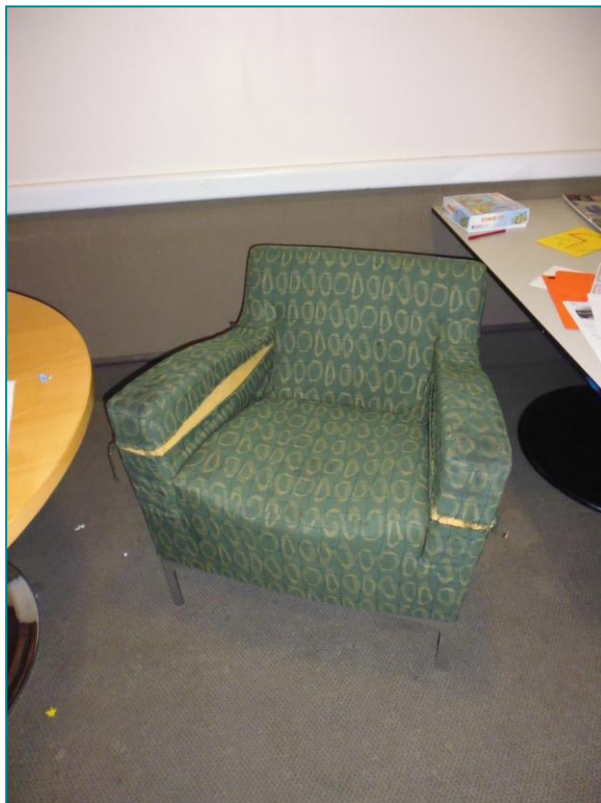
Figure 14: Damaged furniture - ICU

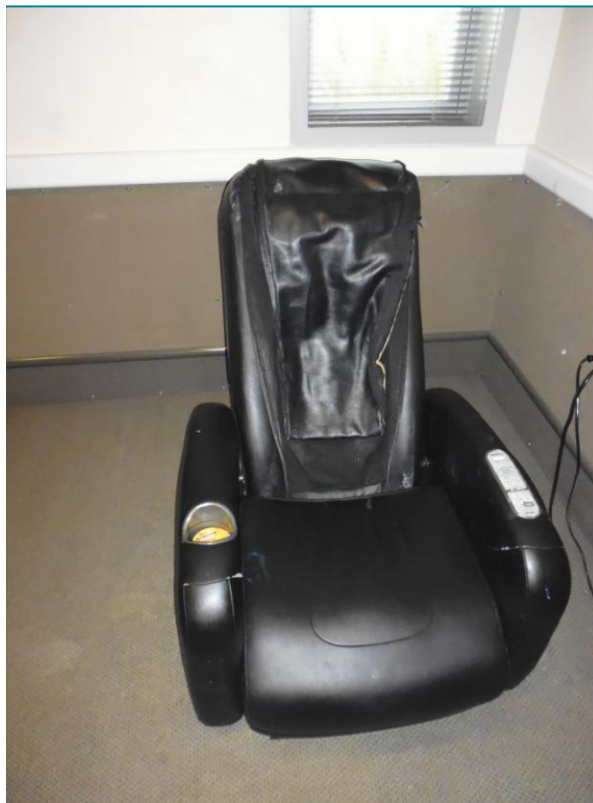
Figure 15: Damaged furniture - ICU

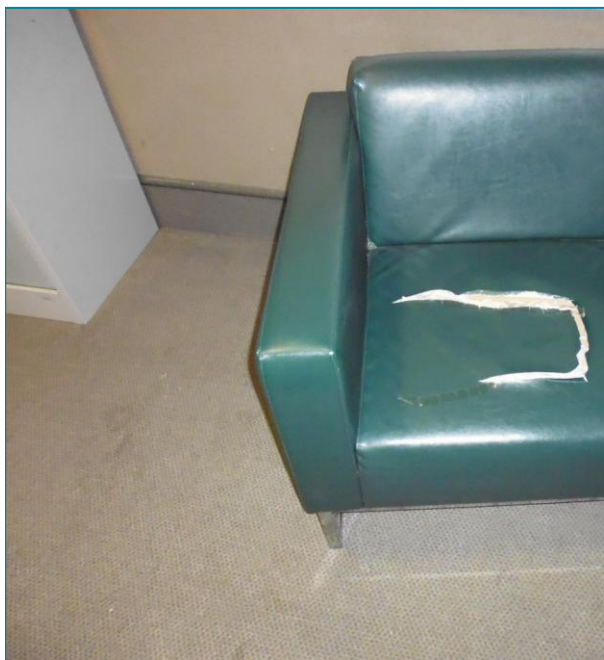
Figure 16: Damaged furniture - ICU

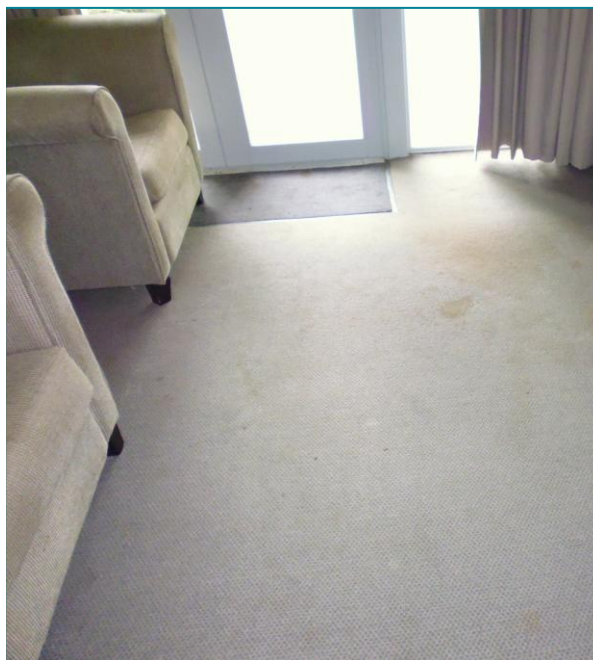
Figure 17: Carpet – main unit

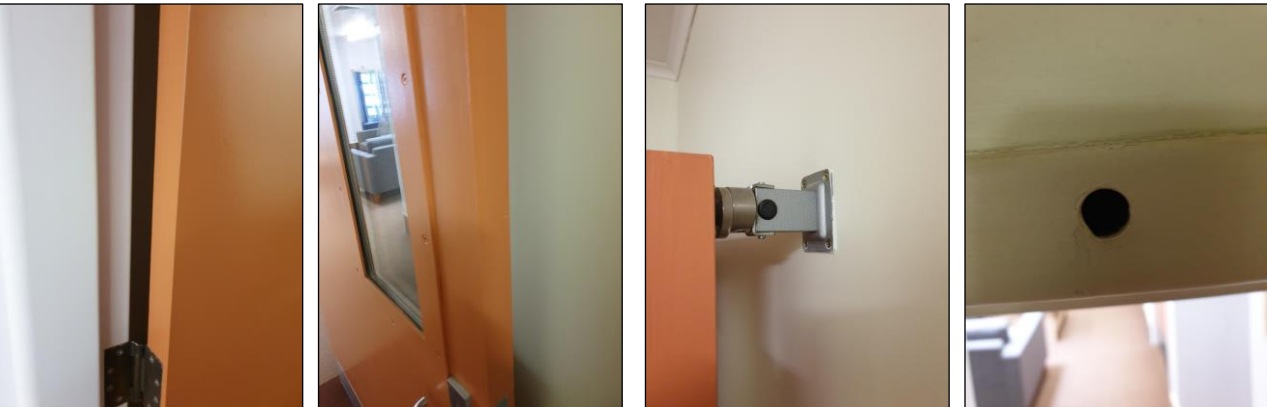
<p>No door tags, no intumescent strips, no solid fill to door frame.</p> <ul style="list-style-type: none"> <li>Install intumescent strips to door, certify doors and fit tags, infill door frame with FR foam.</li> </ul> <p>Defects: Yes</p>
2.

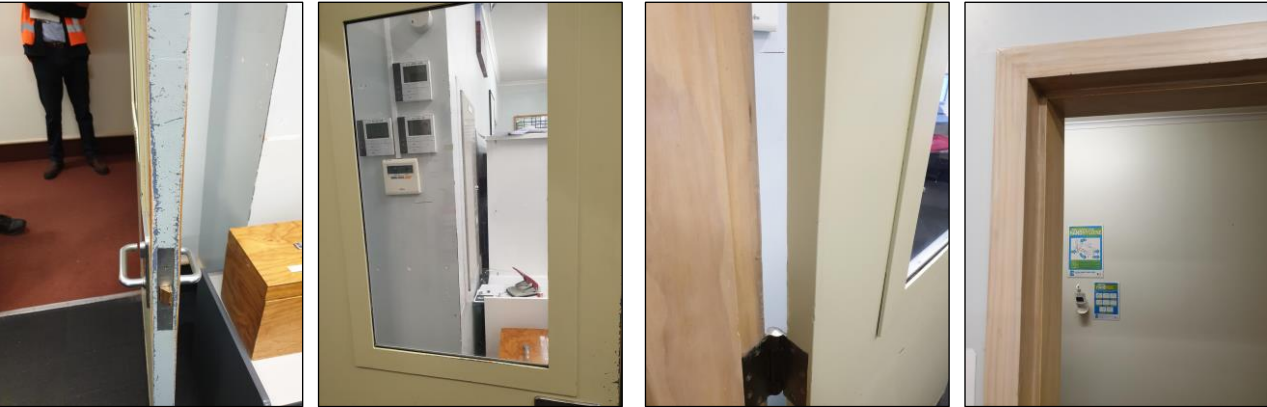
<p>Designated fire door. No door tags, security glass only, no intumescent strips fitted</p> <ul style="list-style-type: none"> <li>Check if door is to be fire rated</li> <li>Install intumescent strips, install FR glass, certify door and fit tags.</li> <li>Check fire rated window to office as it does not appear to be fire rated</li> </ul> <p>Defects: Yes</p>

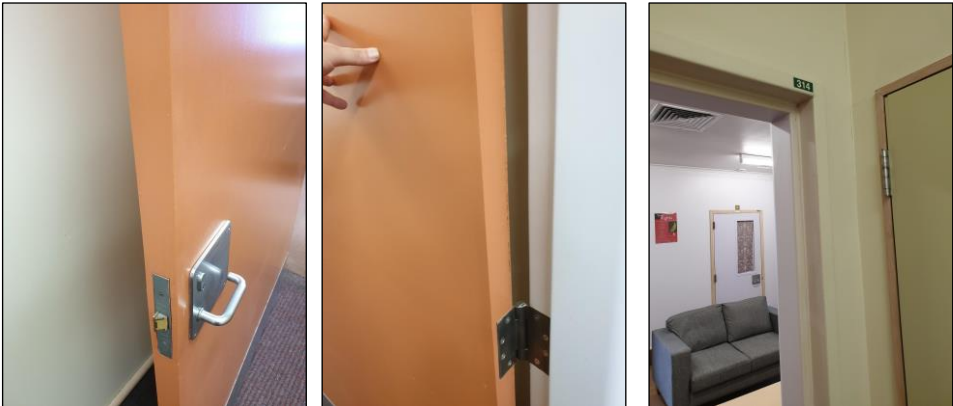
<p>Designated fire door. No door tags fitted, no intumescent strips, no solid fill to door frame.</p> <ul style="list-style-type: none"> <li>Install intumescent strips to door, certify doors and fit tags, infill door frame with FR foam</li> </ul> <p>Defects: Yes</p>
4.

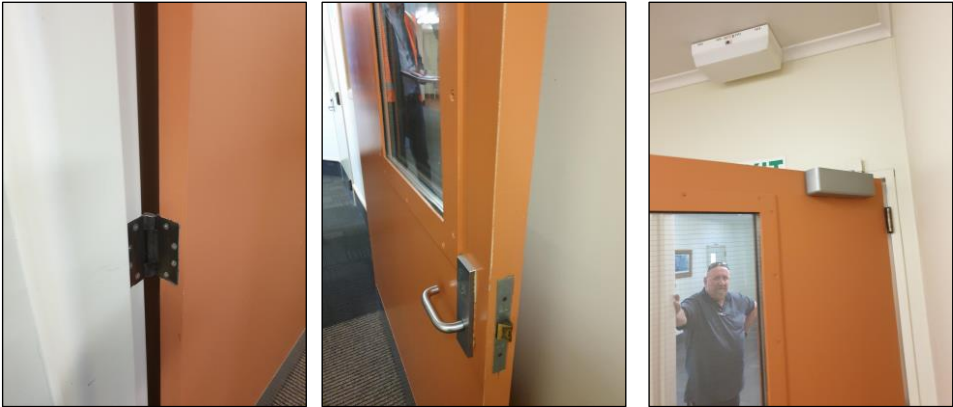
<p>No door tags, no intumescent strips, no solid fill to door frame</p> <ul style="list-style-type: none"> <li>Install intumescent strips to door, certify doors and fit tags, infill door frame with FR foam</li> </ul> <p>Defects: Yes</p>

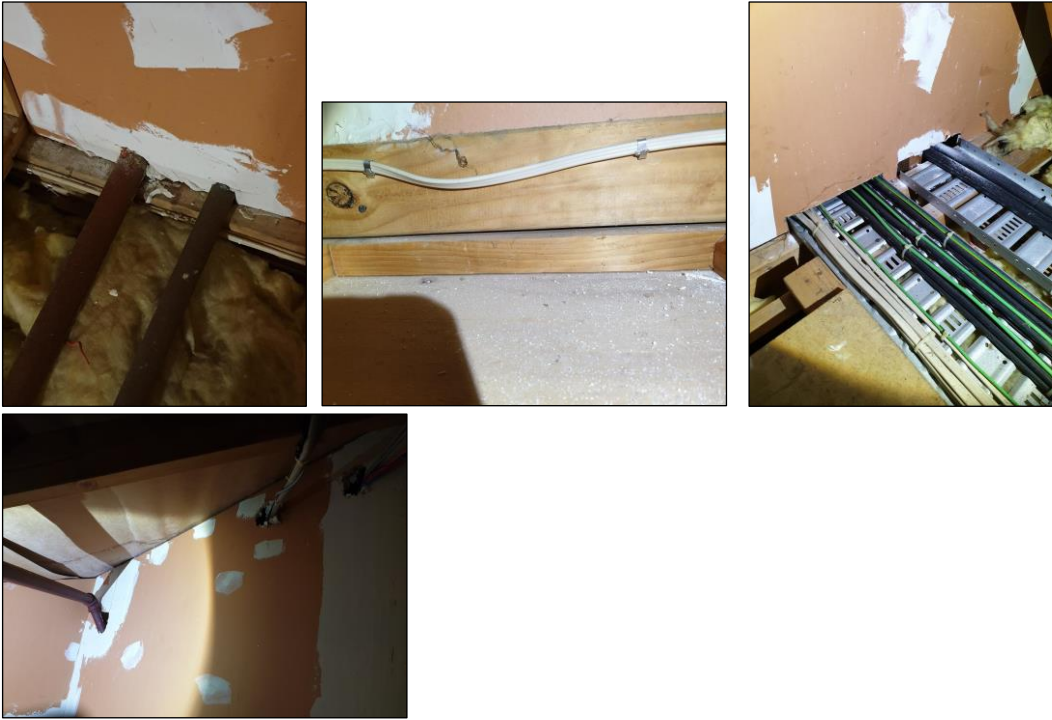
<p>The photo section contains four images: 1. Top-left: Shows exposed wooden studs and insulation in a ceiling area with peeling paint. 2. Top-middle: A close-up of a white cable running along a wooden beam above a concrete floor. 3. Top-right: A view of a server rack with green cables, showing a gap between the rack and the wall. 4. Bottom-left: A view of a ceiling with several circular holes and exposed wiring.</p>	<p>Electrical penetrations through firewall, linear gap and exposed timber.</p> <ul style="list-style-type: none"><li>• Install tested system for cables, infill linear gap with tested system</li><li>• overcoat timber with a tested system.</li></ul> <p>Defects: Yes</p>

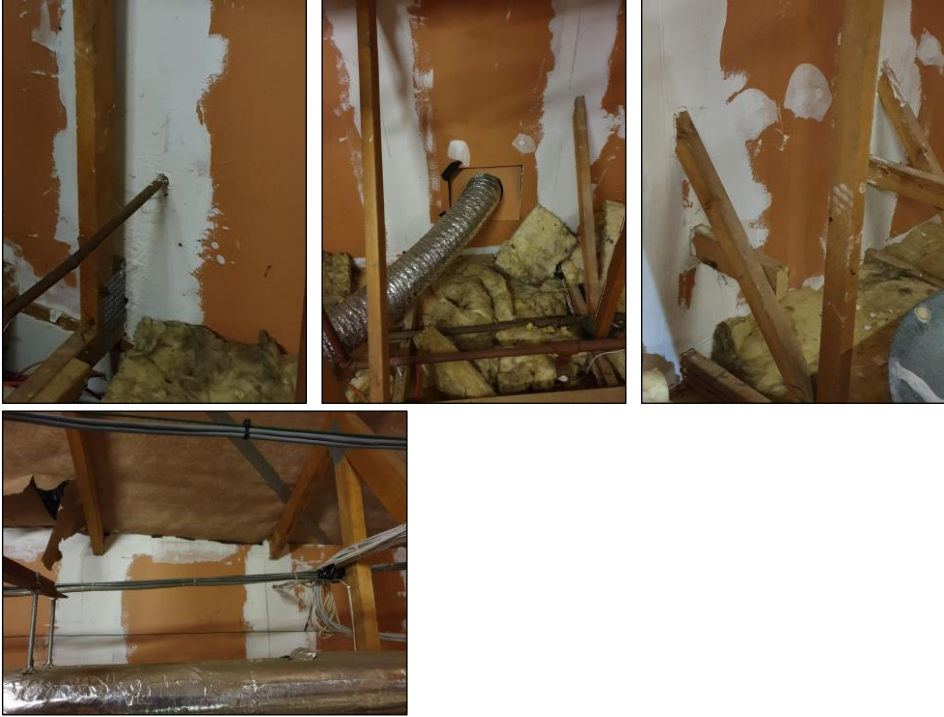
<p>Electrical penetrations through firewall, pipe penetrations through firewall, timber penetrations through firewall.</p> <ul style="list-style-type: none"><li>• Install tested system for pipes</li><li>• Install tested system for cables</li><li>• Install tested system for timber penetrations</li></ul> <p>Defects: Yes</p>

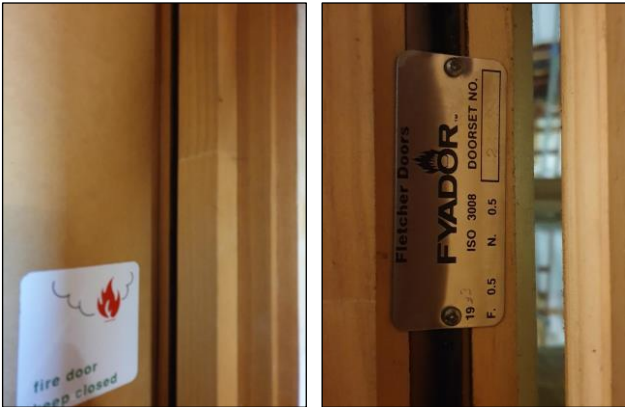
<p>Fire door not closing correctly.</p> <ul style="list-style-type: none"> <li>• Adjust doors closers</li> </ul> <p>Defects: Yes</p>
13.

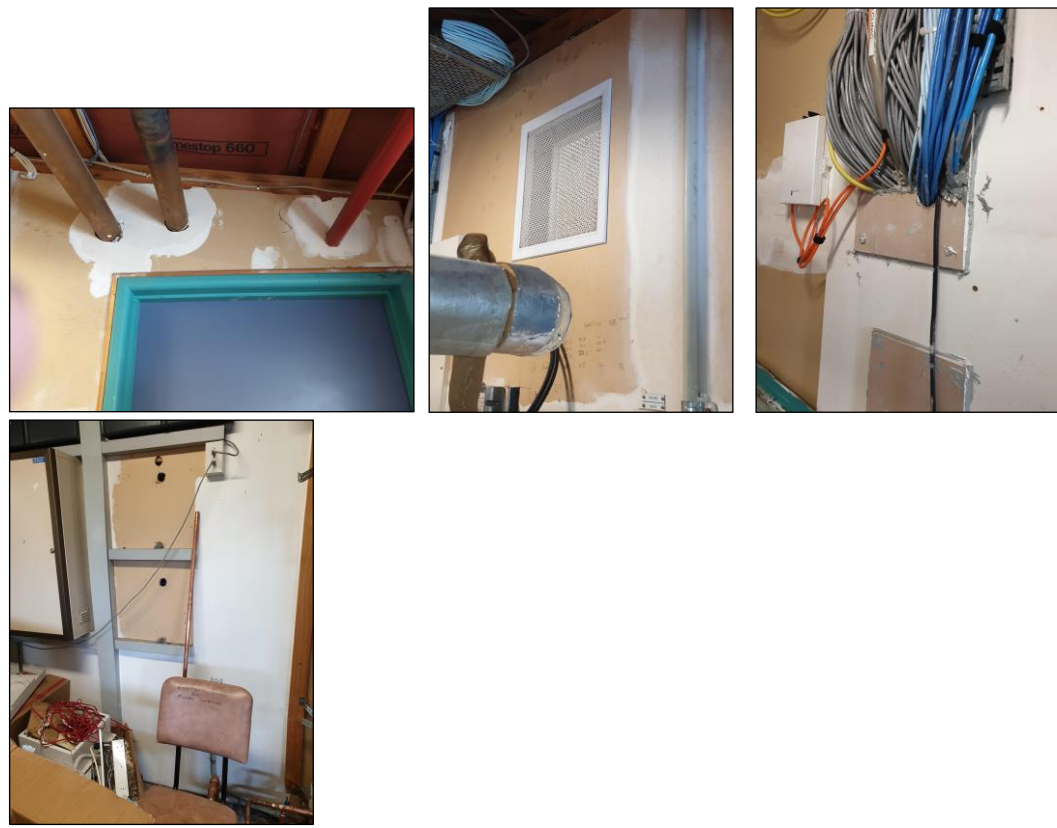
<p>Electrical penetrations through firewall, pipe penetrations through firewall</p> <ul style="list-style-type: none"><li>• Install tested system for pipes</li><li>• Install tested system for cables</li></ul> <p>Defects: Yes</p>

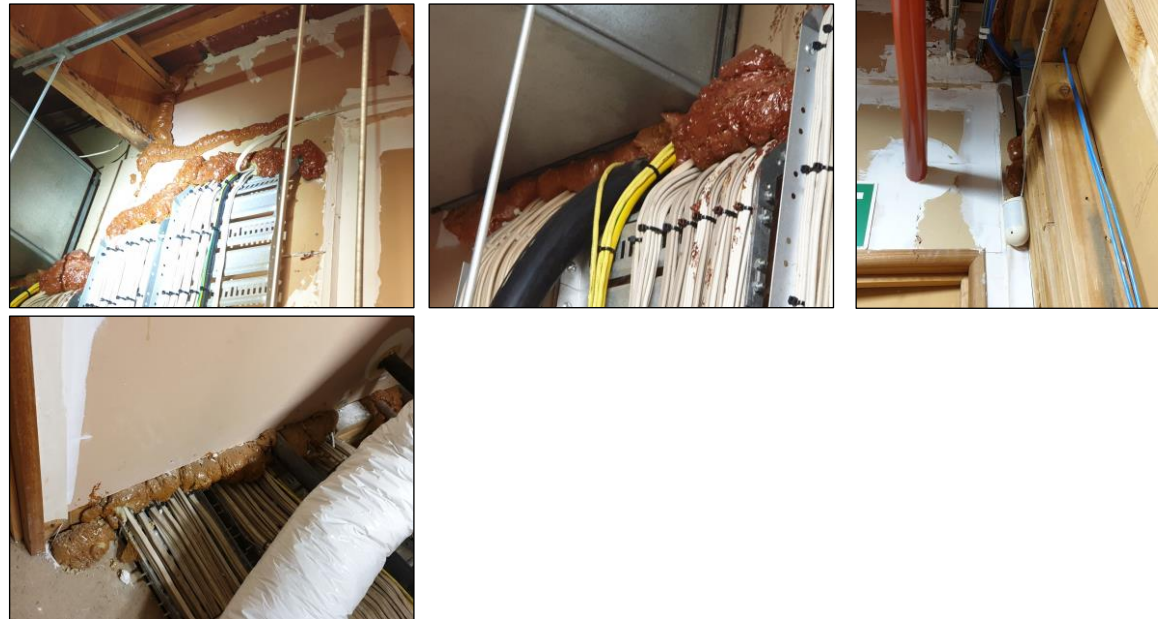
<p>The photographs show a cable tray installation where the tray is completely filled with a thick layer of orange foam insulation. The foam is piled up, preventing the cables from being properly supported and secured. The surrounding area shows wooden framing and other cables, indicating a confined space where this overuse of foam is a significant safety concern.</p>	<p>Overuse of foam</p> <ul style="list-style-type: none"><li>• Potential removal back to face and remediate over</li></ul> <p>Defects: Yes</p>

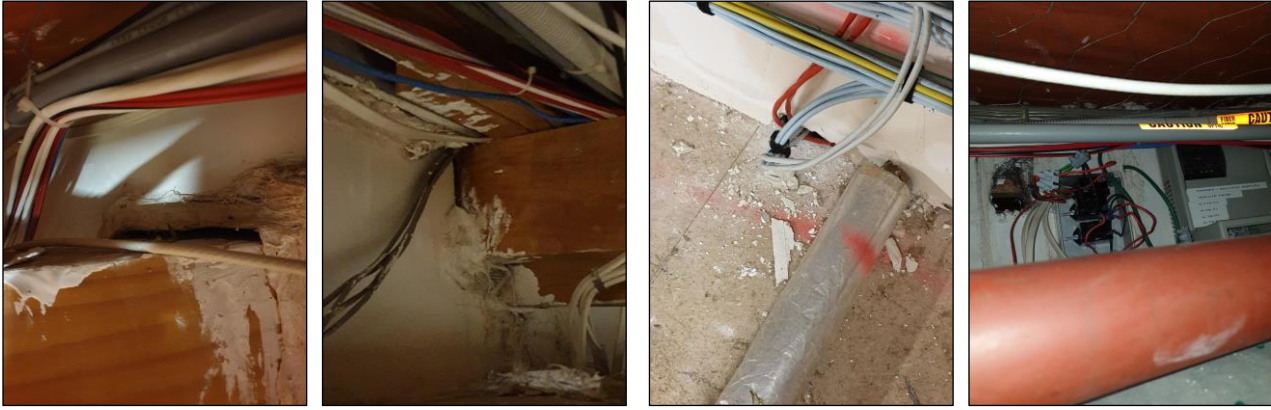
<p>Penetrations incorrectly sealed          Electrical penetrations through firewall,          pipe penetrations through firewall,          timber penetrations through firewall.</p> <ul style="list-style-type: none"> <li>• Remediate fibrous plaster gaps</li> <li>• Install ANARP tested system for pipes</li> <li>• Install ANARP tested system for cables</li> <li>• Install ANARP tested system for timber penetrations</li> </ul> <p>Defects: Yes</p>
21.

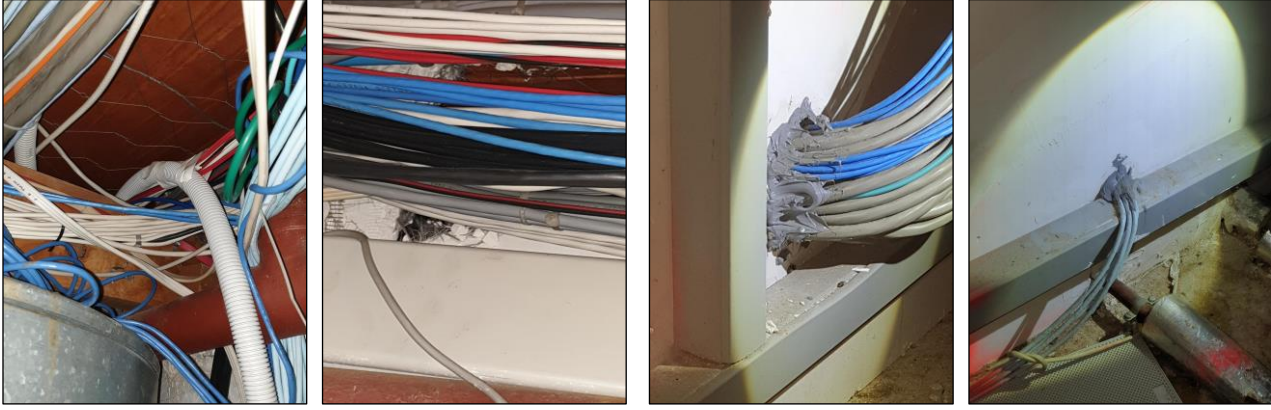
<p>Openings through firewall. Fire wall has been cut to fit walkway and does not extend down to the floor</p> <ul style="list-style-type: none"> <li>• Remediate floor gaps in the fibrous plaster</li> <li>• Install ANARP tested system for pipes</li> <li>• Install ANARP tested system for cables</li> </ul> <p>Defects: Yes</p>

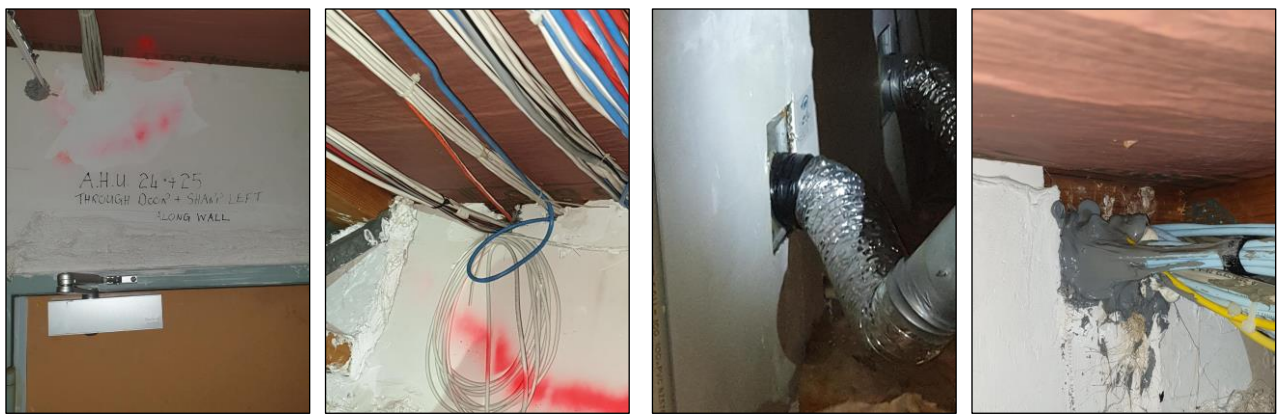
<p>Penetrations incorrectly sealed          Electrical penetrations through firewall,          pipe penetrations through firewall,</p> <ul style="list-style-type: none"> <li>• Remediate fibrous plaster gaps</li> <li>• Install ANARP tested system for pipes</li> <li>• Install ANARP tested system for cables</li> </ul> <p>Defects: Yes</p>
23.

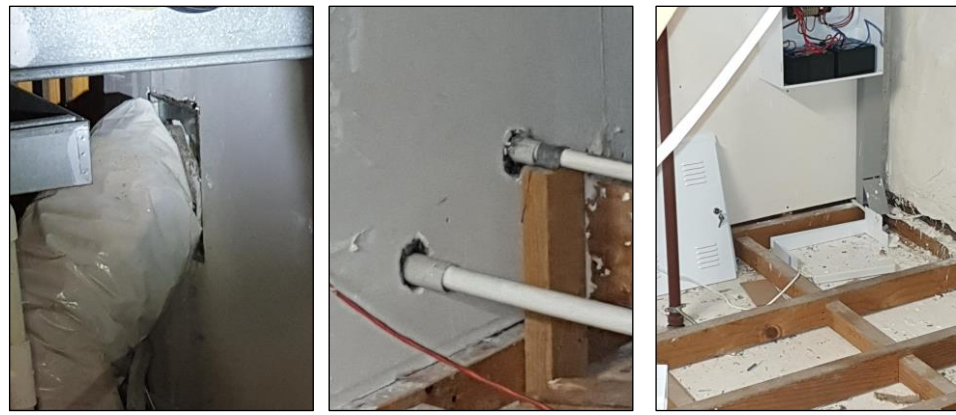
<p>Penetrations incorrectly sealed          Electrical penetrations through firewall,          pipe penetrations through firewall,</p> <ul style="list-style-type: none"> <li>• Remediate fibrous plaster gaps</li> <li>• Install ANARP tested system for pipes</li> <li>• Install ANARP tested system for cables</li> </ul> <p>Defects: Yes</p>

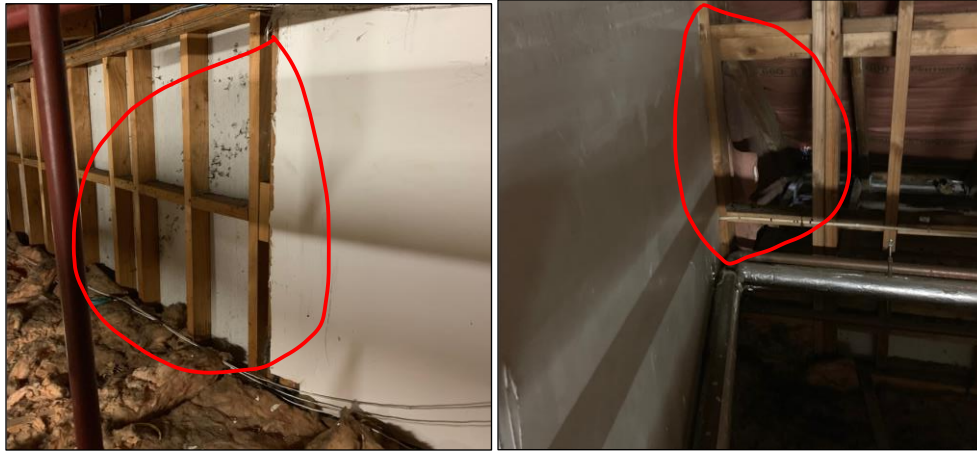
Fire wall not adequately fire separated on each side of the firewall.

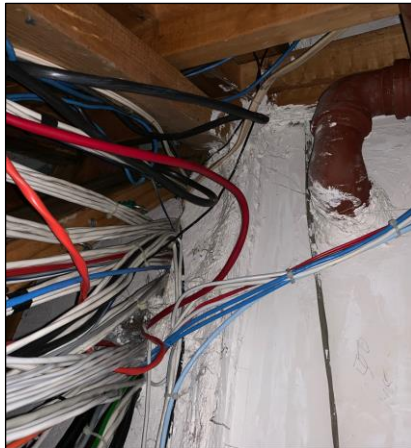
Electrical penetrations through firewall,

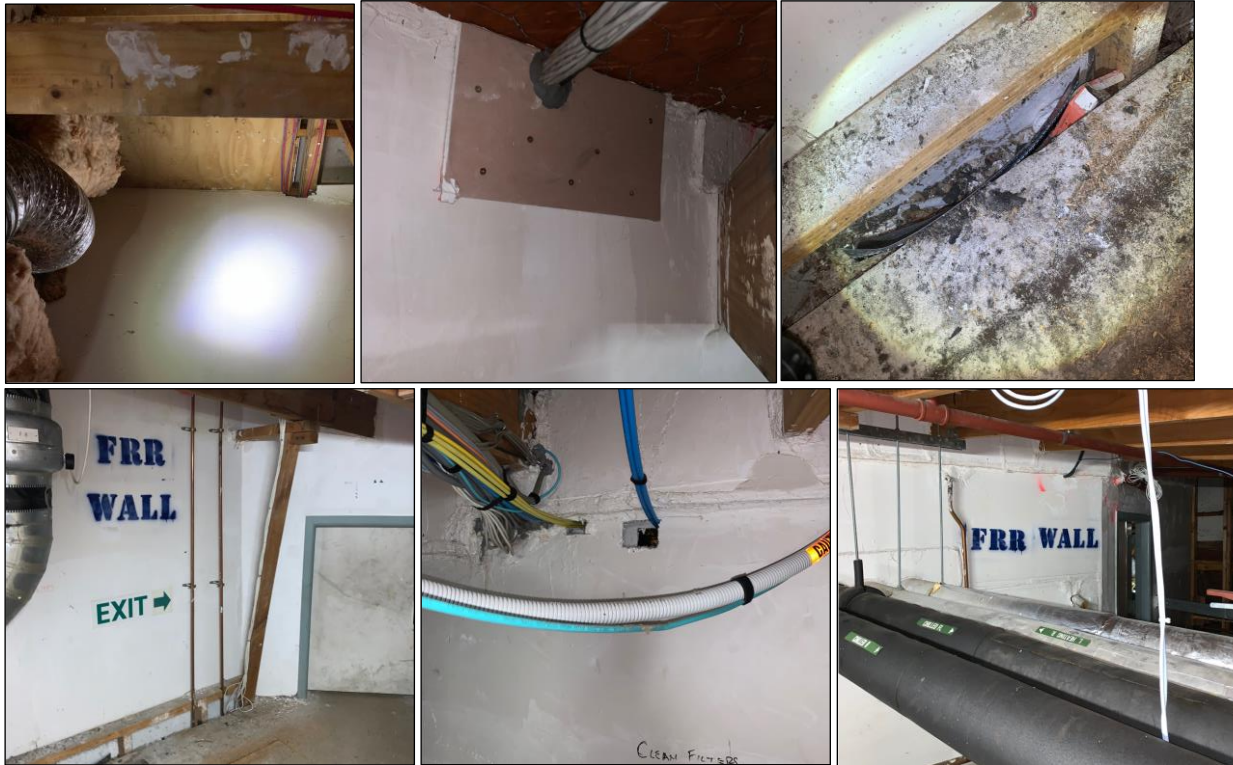
Penetrations incorrectly sealed  
Electrical penetrations through firewall,  
pipe penetrations through firewall,
