Re: OIA request – Asbestos management plans

Asbestos Management Plan

North Shore Hospital Campus

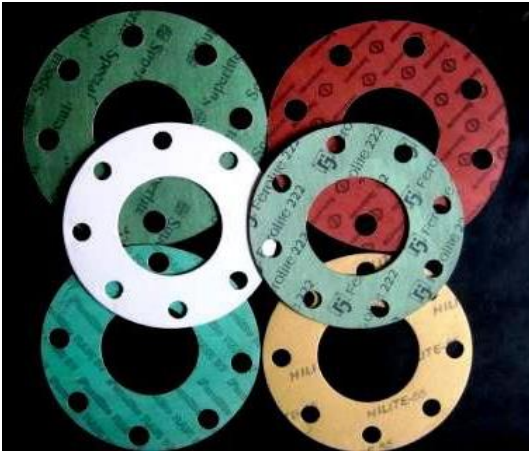
Control Measures		All gaskets are to be presumed to contain asbestos and be left undisturbed unless it can be confirmed that they do not contain asbestos.									
Planned Removal / Remediation		To be tested or removed under appropriate control prior to any works that may cause disturbance.									
Reason for decision		Increased risk of exposure during removal. Low risk of exposure when the gaskets are fully intact and inserted between mating surfaces which restricts access to workers.									
Date of Re-Assessment		N/a	Remediation time scale		As required.

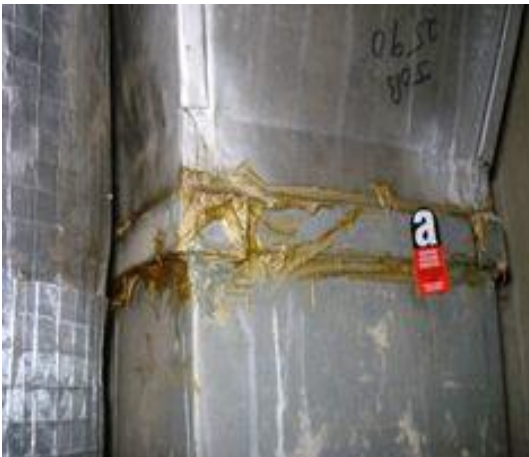
Control Measures		All mastics, putties and sealants are to be presumed to contain asbestos and be left undisturbed unless it can be confirmed that they do not contain asbestos.									
Planned Removal / Remediation		To be tested or removed under appropriate control prior to any works that may cause disturbance.									
Reason for decision		Very low exposure risk in situ due to the material type (hardness or flexibility).									
Date of Re-Assessment		N/a	Remediation time scale		As required

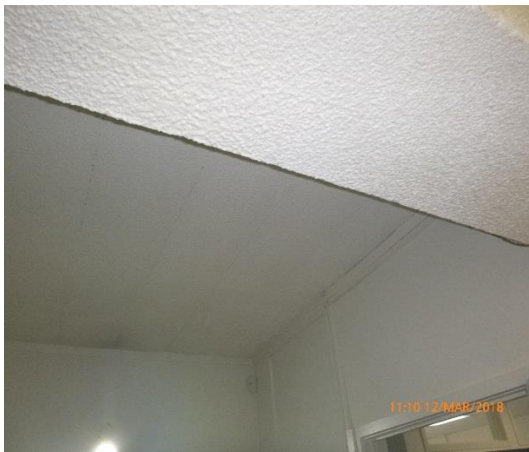
Control Measures		Monitor the Materials Condition – do not disturb the material.									
Planned Removal / Remediation		Remove using a Class A Licensed Asbestos Removal Contractor Prior to Any Works that May Cause a Disturbance.									
Reason for decision		The material presents a low risk of worker exposure in its current condition but may release airborne fibres easily if disturbed during any planned works to the area.									
Date of Re-Assessment		23 rd March 2019	Remediation time scale		As required

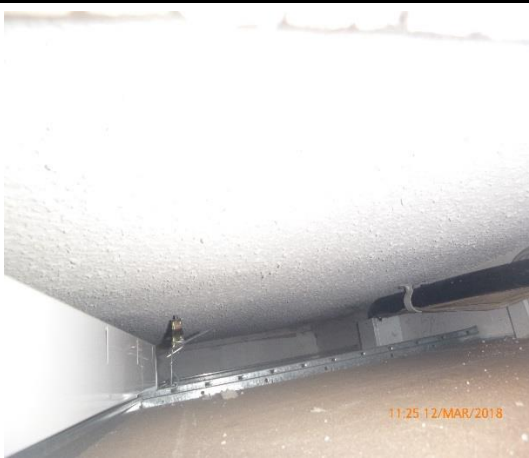
Control Measures		Monitor the Materials Condition – do not disturb the material. Area only partially accessed therefore entry must be risk assessed to determine whether any additional control measures are required.									
Planned Removal / Remediation		Remove using a Class A Licensed Asbestos Removal Contractor Prior to Any Works that May Cause a Disturbance.									
Reason for decision		The material presents a low risk of worker exposure in its current condition but may release airborne fibres easily if disturbed during any planned works to the area.									
Date of Re-Assessment		23 rd March 2019	Remediation time scale		As required

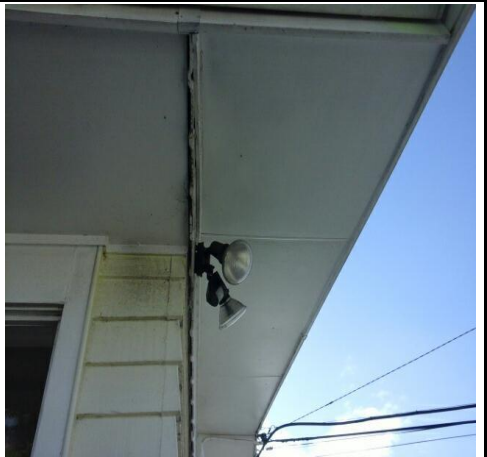
Control Measures		This condition of this material will be monitored – do not disturb									
Planned Removal / Remediation		Removal to be carried out by an appropriately licensed removalist when necessary or prior to any works which could disturb the material.									
Reason for decision		Increased risk of exposure during removal. Material is low risk whilst in situ and in good condition.									
Date of Re-Assessment		19 th April 2019	Remediation time scale		As required.

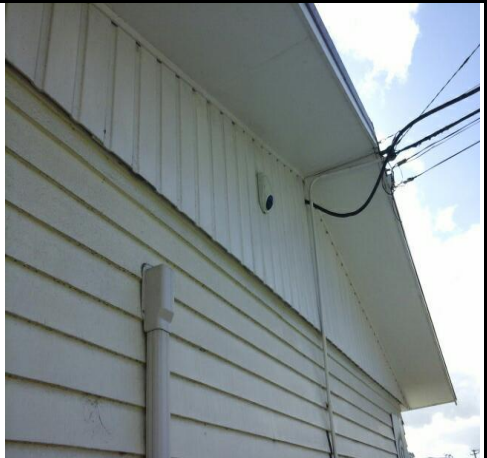
Item #	Level	Material Location	Material Description	Extent	Material Assessment				Accessibility	Labelling Status	Item example photo
					Product	Extent of Damage	Treatment	Surface			
002	Ext.	Profiled High Level Wall Cladding	Fibre Cement	5m2	1	0	1	2	D	Not Labelled

Control Measures		This condition of this material will be monitored – do not disturb									
Planned Removal / Remediation		Removal to be carried out by an appropriately licensed removalist when necessary or prior to any works which could disturb the material.									
Reason for decision		Increased risk of exposure during removal. Material is low risk whilst in situ and in good condition.									
Date of Re-Assessment		19 th April 2019	Remediation time scale		As required

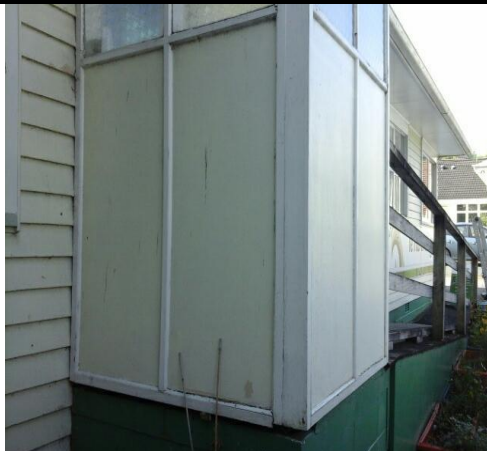
Item #	Level	Material Location	Material Description	Extent	Material Assessment					Accessibility	Labelling Status	Item photo
					Product	Extent of Damage	Treatment	Surface	Score			
003	Ext.	Flat Sheet Wall Cladding to Entrances	Fibre Cement	4m2	1	0	1	2	D	Not Labelled

Control Measures		This condition of this material will be monitored – do not disturb										
Planned Removal / Remediation		Removal to be carried out by an appropriately licensed removalist when necessary or prior to any works which could disturb the material.										
Reason for decision		Increased risk of exposure during removal. Material is low risk whilst in situ and in good condition.										
Date of Re-Assessment		19 th April 2019	Remediation time scale		As required

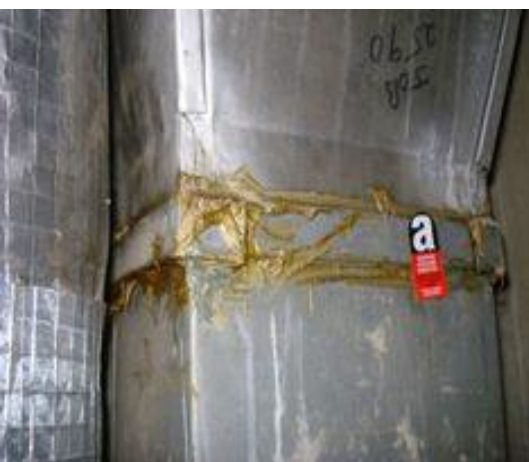
Control Measures		All mastics, putties and sealants are to be presumed to contain asbestos and be left undisturbed unless it can be confirmed that they do not contain asbestos.									
Planned Removal / Remediation		To be tested or removed under appropriate control prior to any works that may cause disturbance.									
Reason for decision		Very low exposure risk in situ due to the material type (hardness or flexibility).									
Date of Re-Assessment		N/a	Remediation time scale		As required

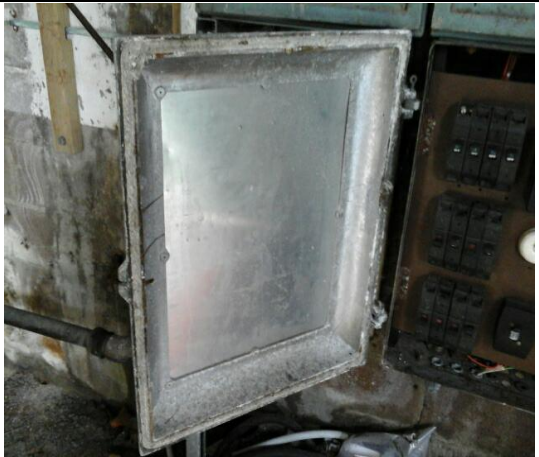
Item #	Level	Material Location	Material Description	Extent	Material Assessment				Accessibility	Labelling Status	Item Photo
					Product	Extent of Damage	Treatment	Surface			
009	Bsmt & Srvc Tunnls	Rope Lining to DB Hatch	Woven Product	1.5lin m	2	2	2	6	E	Not Labelled

Control Measures		Access restricted into area due to items 006, 007 and 008 – do not enter this area unless planned by a competent person.									
Planned Removal / Remediation		Removal by Class A Licensed Asbestos Removal Contractor during friable remediation works throughout the basement and service tunnels.									
Reason for decision		The item cannot be accessed whilst the area is restricted. The risk of any future exposure to workers will be eliminated if removed during friable remediation works in the area.									
Date of Re-Assessment		N/a	Remediation time scale		As required

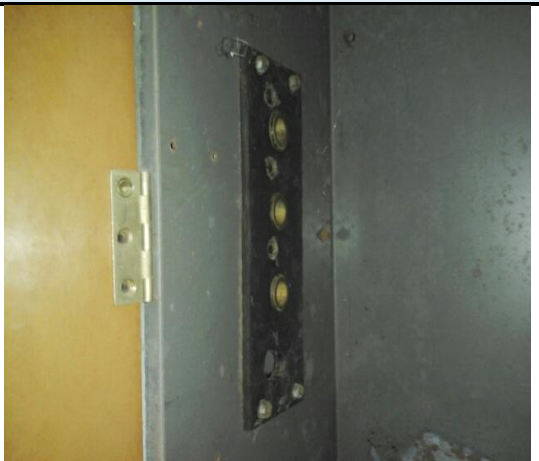
Item #	Level	Material Location	Material Description	Extent	Material Assessment				Accessibility	Labelling Status	Item Photo
					Product	Extent of Damage	Treatment	Surface			
010	Bsmt & Srvc Tunnls	Panels Within and Behind DB Units	Composite	3no	1	1	0	2	D	Not Labelled

Control Measures		Access restricted into area due to items 006, 007 and 008 – do not enter this area unless planned by a competent person.									
Planned Removal / Remediation		Removal during friable remediation works throughout the basement and service tunnels.									
Reason for decision		The item cannot be accessed whilst the area is restricted. The risk of any future exposure to workers will be eliminated if removed during friable remediation works in the area.									
Date of Re-Assessment		N/a	Remediation time scale		As required

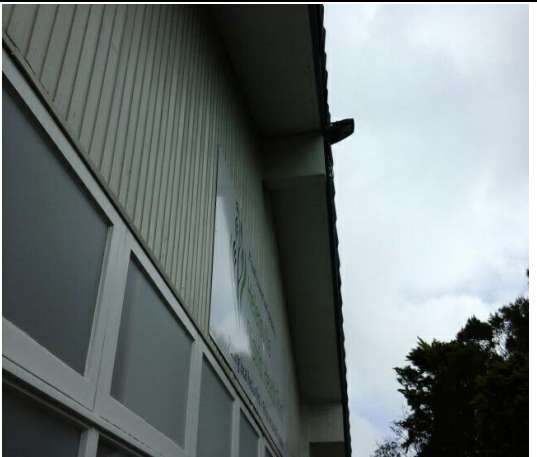
Item #	Level	Material Location	Material Description	Extent	Material Assessment				Accessibility	Labelling Status	Example Photo
					Product	Extent of Damage	Treatment	Surface			
013	Ext.	Soffits	Fibre Cement	200lin m	1	0	0	1	D	Not Labelled

Control Measures		This condition of this material will be monitored – do not disturb									
Planned Removal / Remediation		Removal to be carried out by an appropriately licensed removalist when necessary or prior to any works which could disturb the material.									
Reason for decision		Increased risk of exposure during removal. Material is low risk whilst in situ and in good condition.									
Date of Re-Assessment		19 th April 2019	Remediation time scale		As required.

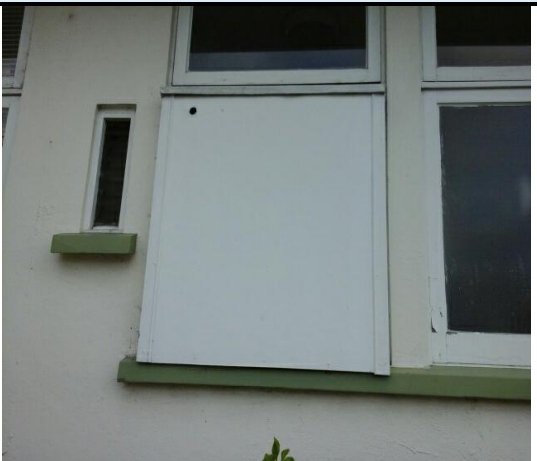
Item #	Level	Material Location	Material Description	Extent	Material Assessment				Accessibility	Labelling Status	Item Photo
					Product	Extent of Damage	Treatment	Surface			
017	Ext.	Panel to Wall of Community Health	Fibre Cement	1m ²	1	1	1	3	D	Not Labelled

Control Measures		This condition of this material will be monitored – do not disturb									
Planned Removal / Remediation		Removal to be carried out by an appropriately licensed removalist when necessary or prior to any works which could disturb the material.									
Reason for decision		Increased risk of exposure during removal. Material is low risk whilst in situ and in good condition.									
Date of Re-Assessment		19 th April 2019	Remediation time scale		As required.

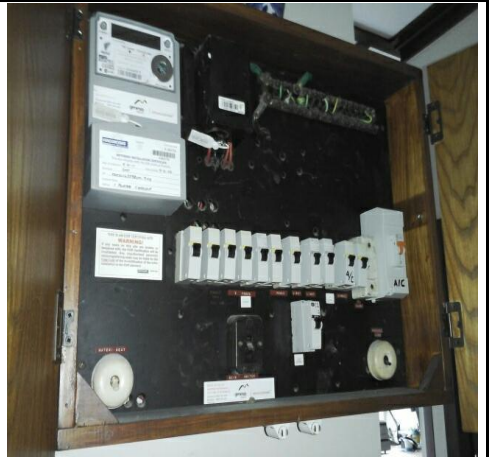
Item #	Level	Material Location	Material Description	Extent	Material Assessment				Accessibility	Labelling Status	Item photo
					Product	Extent of Damage	Treatment	Surface			
001	Grnd	Electrical Backboard	Composite	0.5m ²	1	1	0	2	D	Not labelled

Control Measures		The item will be labelled and its condition monitored – do not disturb.									
Planned Removal / Remediation		Removal to be carried out when necessary or prior to any works which could disturb the material.									
Reason for decision		Increased risk of exposure during removal. Material is low risk whilst in situ and in good condition.									
Date of Re-Assessment		19 th April 2019	Remediation time scale		As required

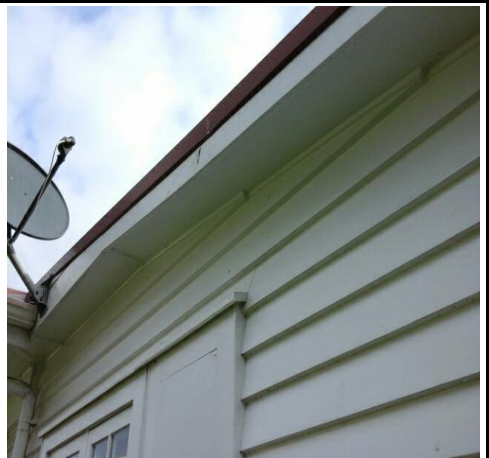
Item #	Level	Material Location	Material Description	Extent	Material Assessment				Accessibility	Labelling Status	Item example photo
					Product	Extent of Damage	Treatment	Surface			
002	Ext.	Soffits to Extension	Fibre Cement	3lin m	1	0	1	2	D	Not labelled

Control Measures		This condition of this material will be monitored – do not disturb.									
Planned Removal / Remediation		Removal to be carried out by an appropriately licensed removalist when necessary or prior to any works which could disturb the material.									
Reason for decision		Increased risk of exposure during removal. Material is low risk whilst in situ and in good condition.									
Date of Re-Assessment		19 th April 2019	Remediation time scale		As required
