**Re: OIA request – Mental Health unit data**

Thank you for your Official Information Act request received 10 December 2020 seeking information from Waitematā District Health Board (DHB) about our mental health facilities.

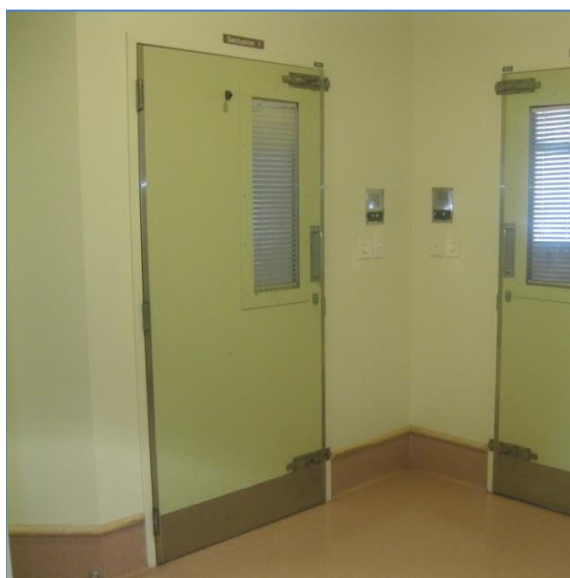
Figure 1: Seclusion area

15. There are two seclusion rooms of which one (with a hospital bed) can be used as a bedroom, if necessary. A separate toilet/shower area is located adjacent to the seclusion rooms. Both rooms have natural light, privacy blinds (working) and a means of calling for attention.

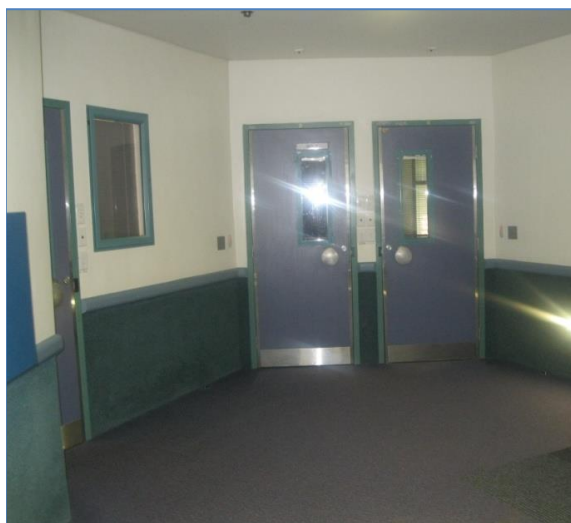
Figure 3: Pod

- 43. There are three accommodation areas in the Unit (pods) containing four bedrooms, a shower and separate toilet. One bedroom has en-suite facilities. Rooms are relatively

basic with a bed, storage space, bench and means of calling for assistance. All windows and doors have privacy blinds. The blinds tested were working.

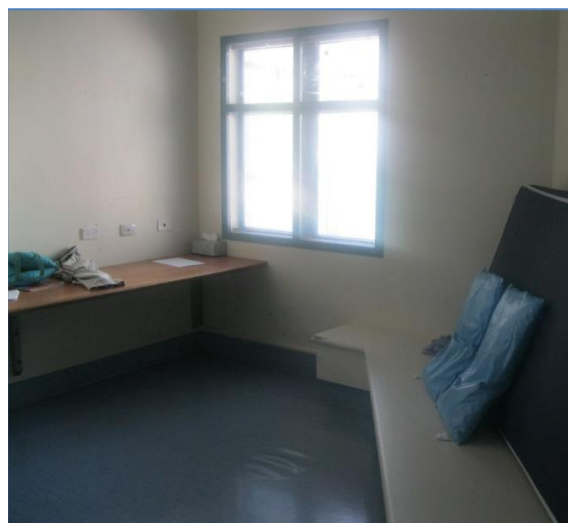
Figure 4: Typical bedroom

44. There are several, small communal and recreational lounges which service users can access throughout the day. All areas, including bedrooms were looking tired and drab and in need of an upgrade.

45. The Mason Clinic has a number of buildings that have deteriorated significantly over several years as a result of water damage. Rata Unit is one of those buildings. A works programme has been established to progressively address repairs to the affected buildings<sup>4</sup>.

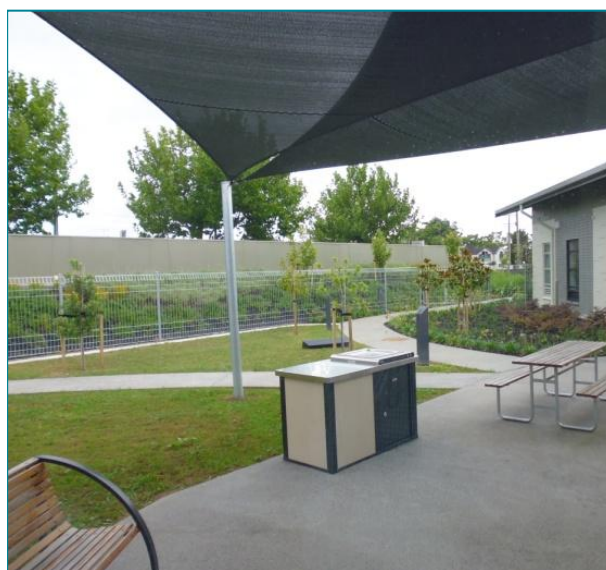
Figure 7: Non-accessible courtyard

69. For service users in the main units (Rongoa and Rerewai) there are two large garden areas which offer adequate privacy, seating and shade; however, the door into the gardens was locked at the time of the visit. For service users in the HCU, smaller (secure) yards are available although only the male yard was open during the course of the visit.

70. When questioned, staff informed the Inspectors that the doors were temporarily locked due to several high profile service users absconding from the Unit. However, planned activities under staff supervision (internal courtyard only – and contingent on staffing numbers) do take place. There is no record of when the courtyard is open, what activities are offered and who accesses them.
71. We were informed that the fence around the main courtyard needed to be raised to prevent absconding and that this planned work would take place before the end of March 2016. Unless service users have approved unit leave (and not everyone did) not all service users can access fresh air.
72. The Inspectors were concerned that not all service users have access to fresh air daily.

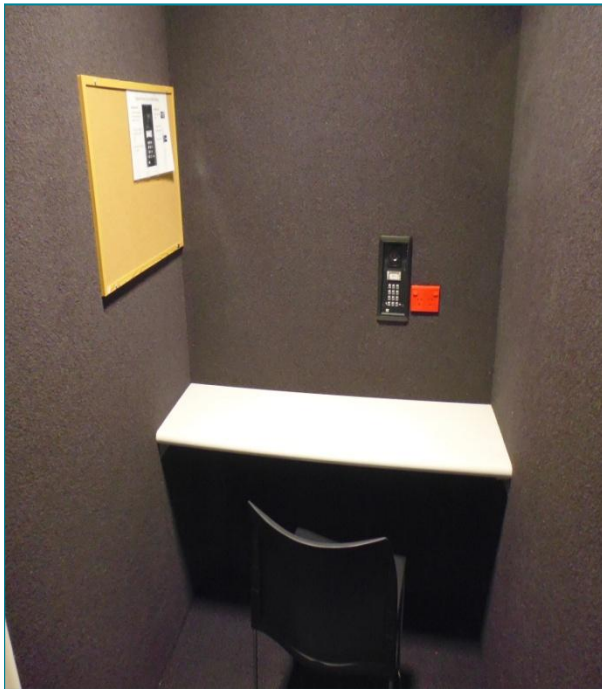
Figure 13: Telephone booth – not working

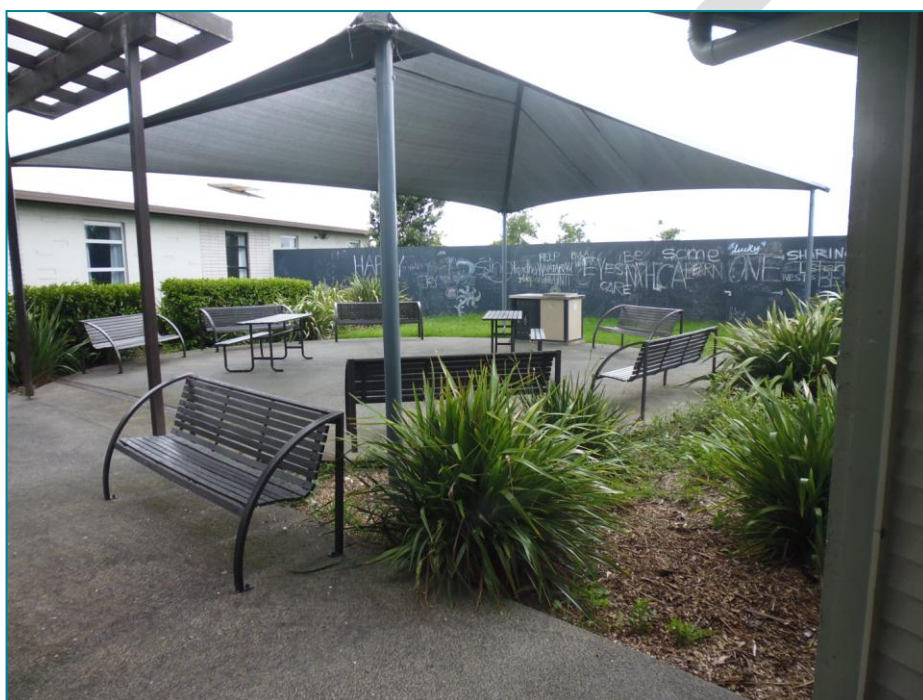
Figure 9: Unit courtyard

50. For clients in the main unit, there is a large garden area at the rear of the Unit which offers adequate privacy, seating and shade; however, the door into the garden was locked at the time of the visit.

51. When questioned, staff informed the Inspectors that the door is only opened for planned activities and under staff supervision (an average of one hour a day - contingent on staffing numbers). There is no record of when the courtyard is open and who accesses it.
52. Due to the secure nature of the ICU courtyard, clients can access the courtyard throughout the day.
53. We were informed that the wall around the main courtyard needed to be raised to prevent absconding and that this work has gone out for tender. Currently clients cannot access the courtyard without staff being present and the Inspectors were not confident that clients had access to fresh air daily.

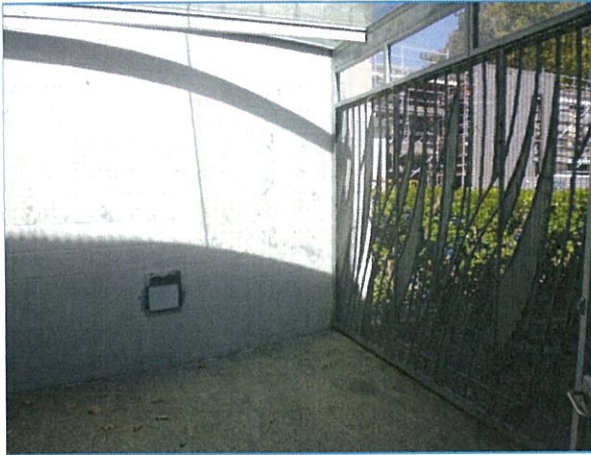
Figure 1: Courtyard

16. On the day of inspection there were no clients in high care/seclusion.
17. The high care area had two seclusion rooms and a lounge area with a small enclosed courtyard. Some seating in the lounge area was in need of repair or replacement.
18. One of the two seclusion rooms had a soft padded covering around the walls and floor which needed some repairs. Both rooms, although very basic, had natural light, heating, ventilation and working blinds. Both rooms contained a mattress and bedding and were clean and tidy.
19. Opposite the seclusion rooms were the toilet and shower facilities; both well maintained and clean.

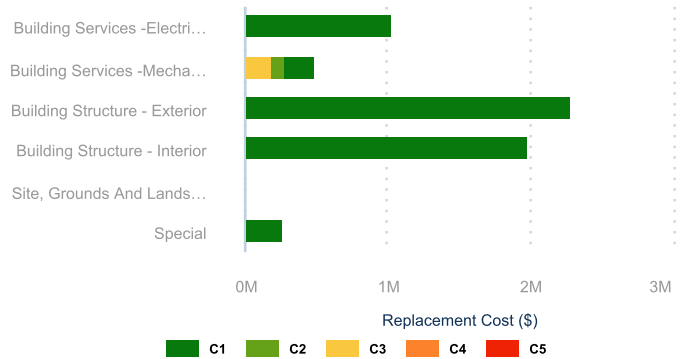
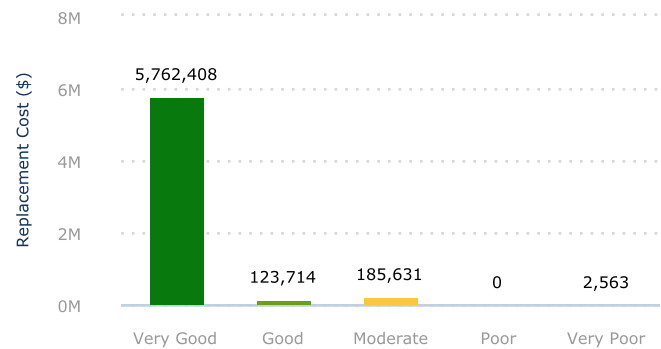
The condition profile for the building is shown on the right. A very low proportion of components by number and value were assessed to be in very poor condition, everything else being in good or very good condition.

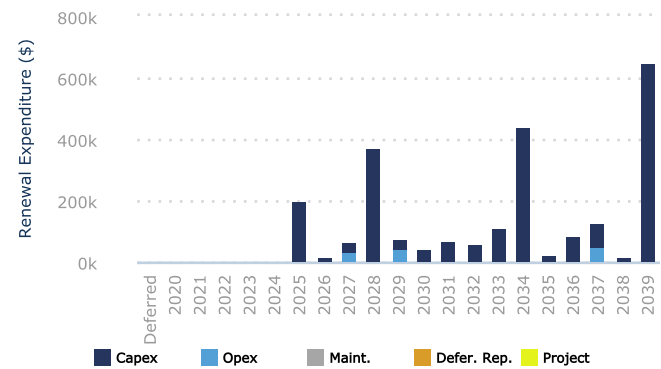
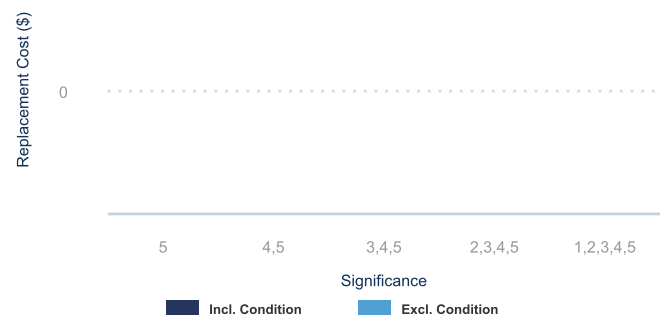
The 20 year renewals expenditure forecast for this building is displayed opposite. As would be expected from a near new building there is negligible forecast expenditure on renewals in the next seven years based on the survey assessment. The first significant item of expenditure over the next 10 years is forecast to occur in 2025 which is primarily associated with replacement of smoke detectors. In 2026 the expenditure is forecast to spike to well above the 20 year average which is primarily associated with forecast need to replace flatscreen TVs, paint finishes and

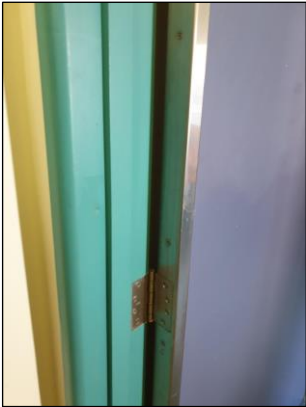
<p>No door tags.</p> <ul style="list-style-type: none"> <li>• Fit door tags</li> </ul> <p>Defects: Yes</p>

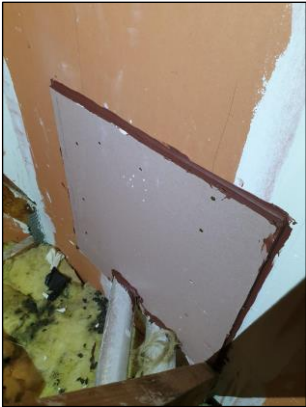
<p>Pipe penetrations through firewall</p> <ul style="list-style-type: none"> <li>•</li> </ul> <p>Defects: No</p>

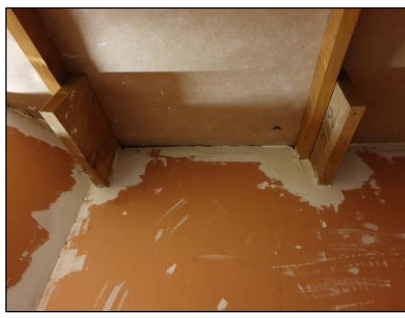
Ref	Photo	Notes
14.

<p>Timber penetrations through firewall.</p> <ul style="list-style-type: none"><li>• Install tested system for timber penetrations</li></ul> <p>Defects: Yes</p>

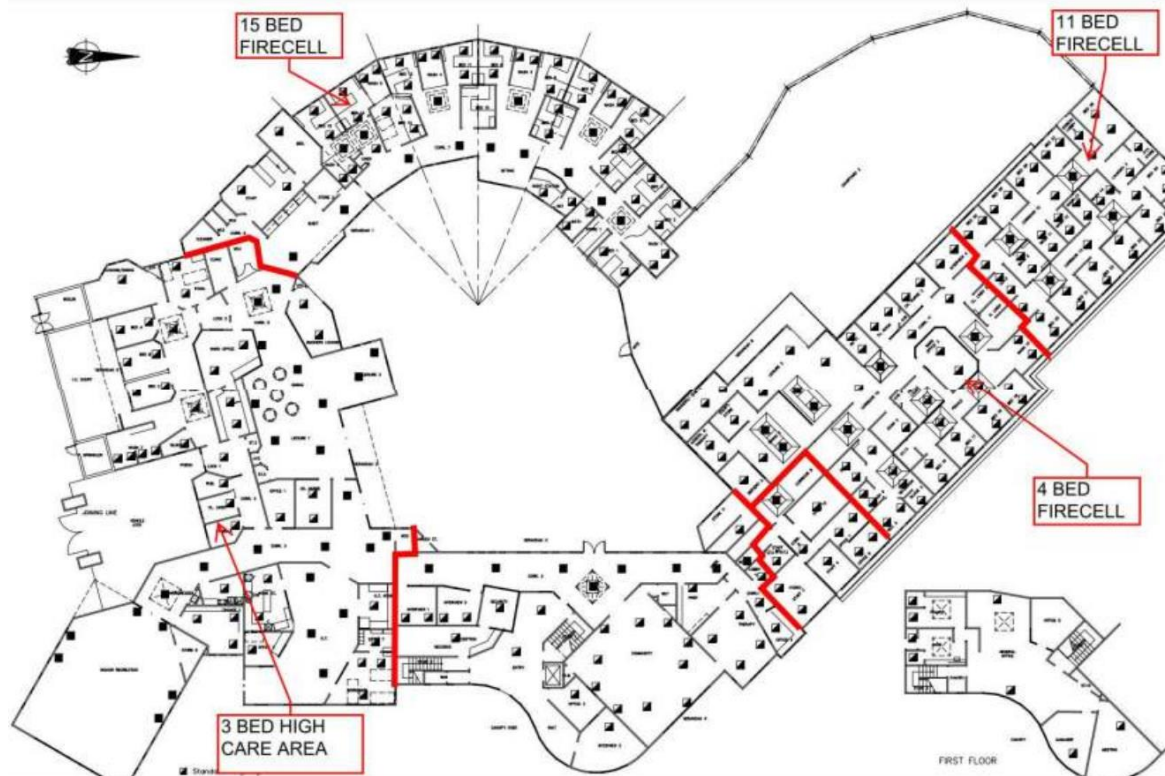
**The Totara/Kauri Building is a single level high security accommodation**
